# NAVAL POSTGRADUATE SCHOOL

### COMBAT DAMAGE ASSESSMENT TEAM

A-10/GAU-8 LOW ANGLE FIRINGS

SIMULATED SOVIET TANK COMPANY (ARRAY 18)

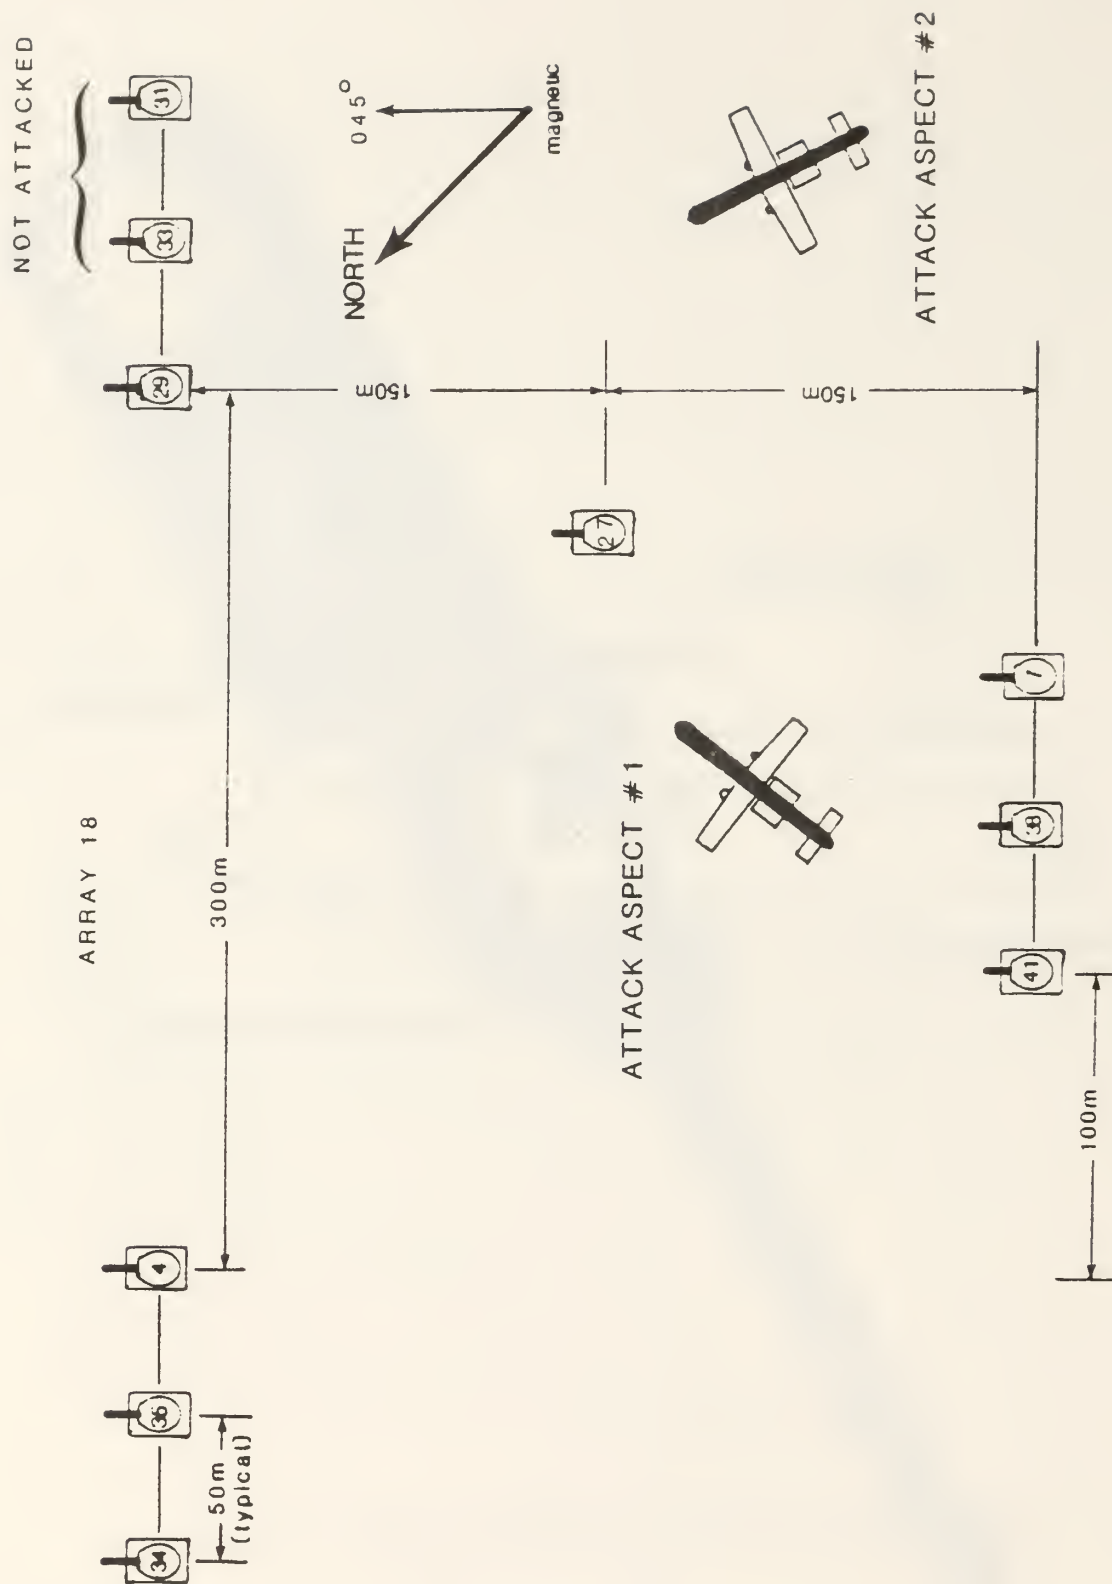
FIGURE 6. Approximate Target Layout.

The data noted immediately above were collected through the combined efforts of the CDAT and range support personnel at Nellis AFB, working together and using TSPI equipment, motion picture and still cameras, the industrial efforts required to repair, refurbish, and field the tank targets, and various systematic research techniques used to describe weapon effects and combat damage. The most basic materiel used in the test; i.e., the aircraft, gun, and projectile are illustrated in Figures 2, 3, 4, and 5. The tanks were arrayed in the tactical formation of a Soviet tank company as shown in Figure 6.

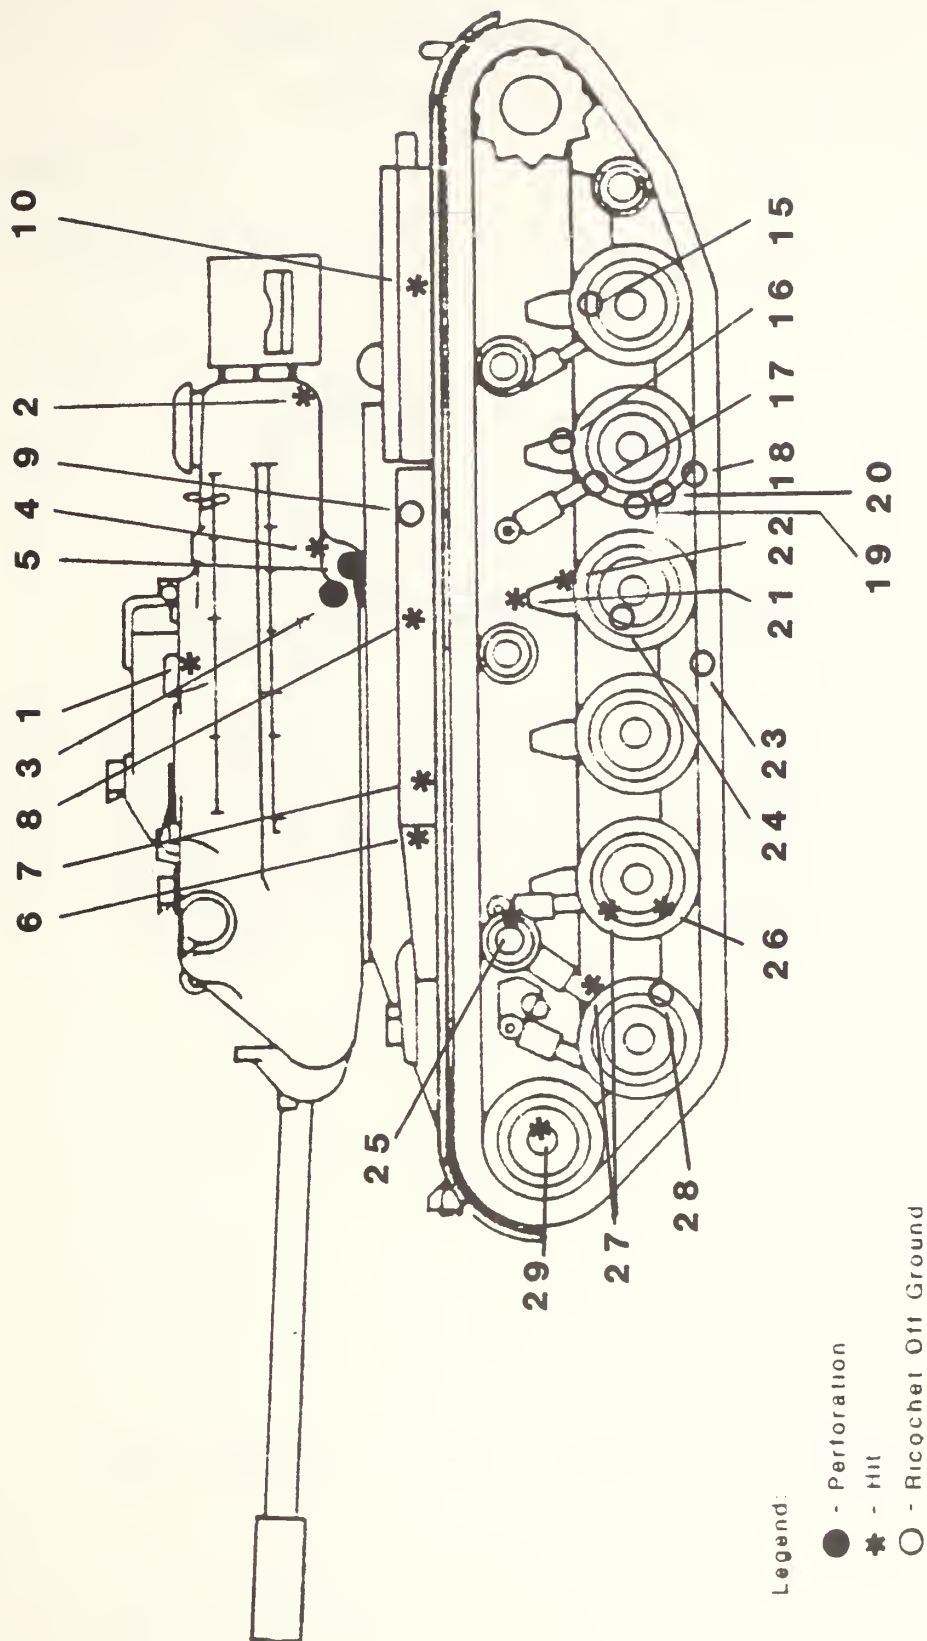
FIGURE 7. Tank 41, Impact Diagram, Left Side.

100% M-Kill and 95% F-Kill resulting from the following observed projectile effects (Figure 7 and 8):

- a. M-Kill: The assessment of 100% M-Kill was based on impact 29 which penetrated the left track adjusting idler hub, cumulative damage to the track and suspension system from impacts 12, 14, 24, 25, and 28, and impacts 3 and 5 which perforated the left turret and caused casualties to the commander, gunner, and loader.
- b. F-Kill: The assessment of F-Kill was based on the commander, gunner and loader casualties.

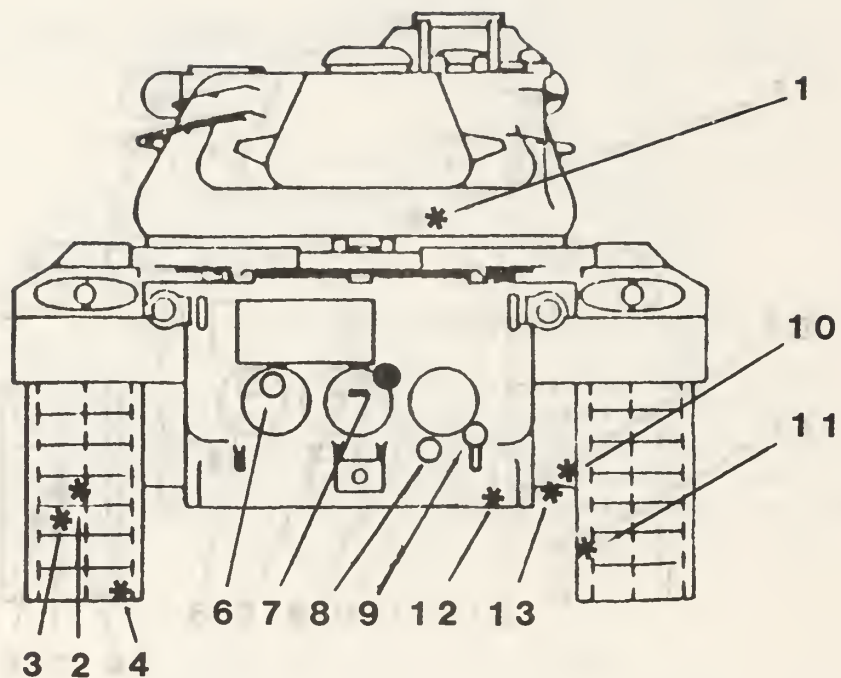
FIGURE 9. Tank 38, Impact Diagram, Rear.

100% M-Kill based on the following observed effects (Figures 9, 10, and 11):

100% M-Kill based on impact 7 which perforated the rear of the hull (see Figure 12) and penetrated into the transmission case; impact 10, which penetrated into the right final drive; and cumulative damage to the track and suspension system caused by impacts 4, 11, 18, and 19.

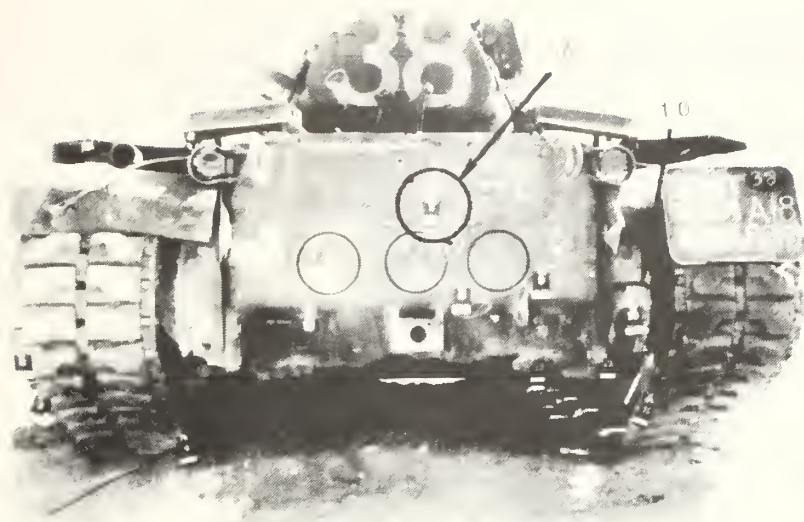
FIGURE 12. Tank 38, Photo, Rear.

Note impacts 7 and 10 which perforated the hull and the right final drive casting respectively and contributed to the assessment of 100% M-Kill.

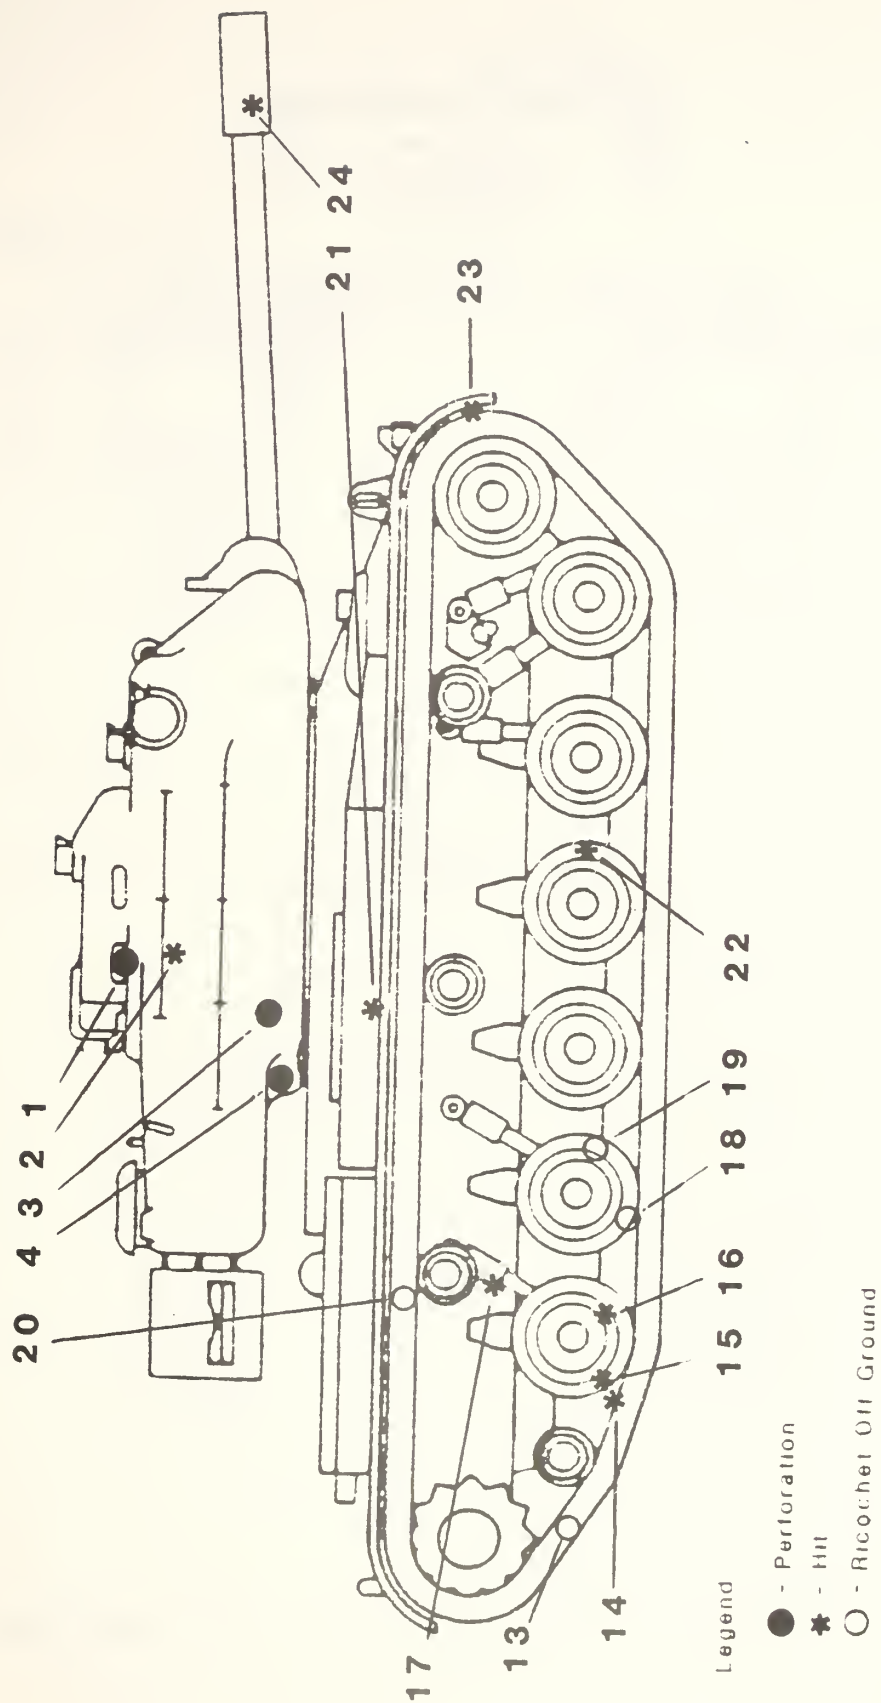
FIGURE 13. Tank 35, Impact Diagram, Right Side.

95% M-Kill and 100% F-Kill resulting from the following observed effects (Figures 13 and 14):

a. M-Kill: A 95% M-Kill was assessed based on impacts 1, 3, and 4 which perforated the right turret causing casualties to the commander, gunner, and loader degrading mobility (90%) and on cumulative damage (5%) to the track and suspension system by impacts 13, 14, 17, 18, and 22.

b. F-Kill: A 100% F-Kill was assessed based on impact 4 which perforated the turret ring and jammed the turret so that it would not traverse, and on the commander, gunner, and loader casualties inflicted by impacts 1 and 3. Impact 24, which penetrated the bore evacuator, made a minor contribution to the kill.

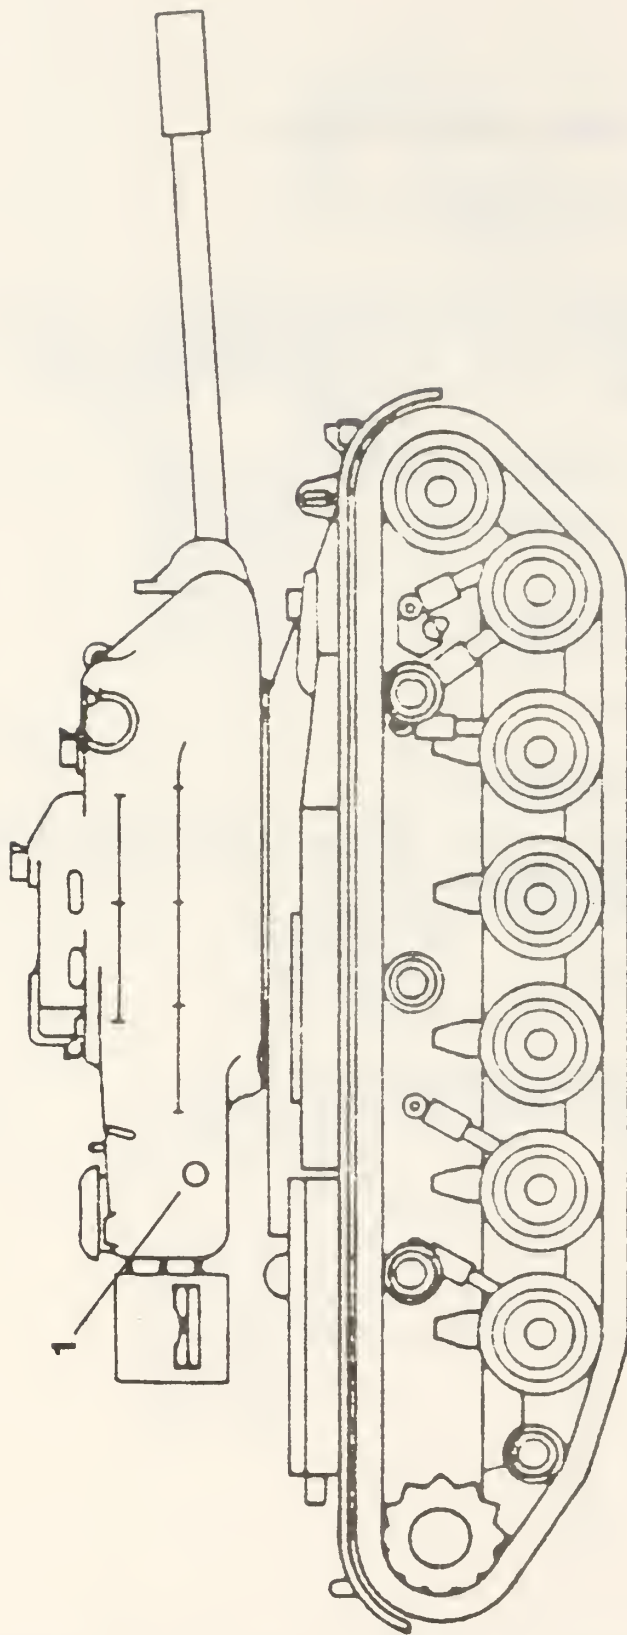
The single impact on tank 34 partially penetrated the right side of the turret (Figure 15) with no behind-the-plate effects.

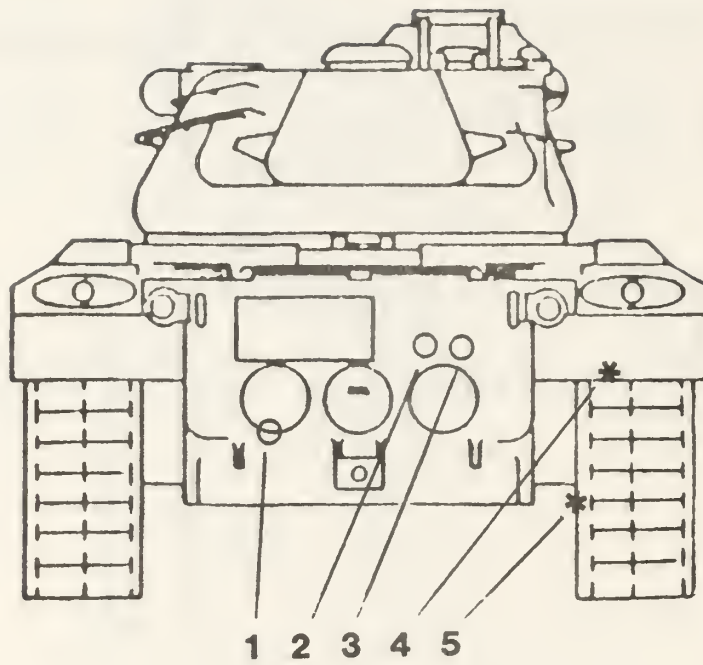
None of the impacts on tank 29 (Figure 16) contributed to the assessment of either an M- or an F-Kill.

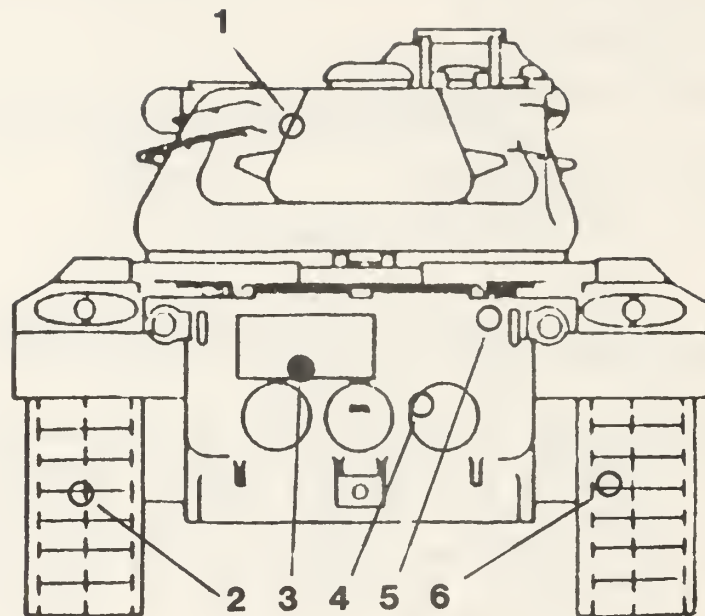
All of the impacts on the target were ricochets off the ground. Impact 3 (Figure 17) perforated the rear hull armor but did not possess enough residual energy to penetrate into the transmission case. The remaining five projectiles impacted the track and suspension system, hull, and turret with no harmful effects on mobility or firepower.

Note: Perforation resulted from ricochet off ground

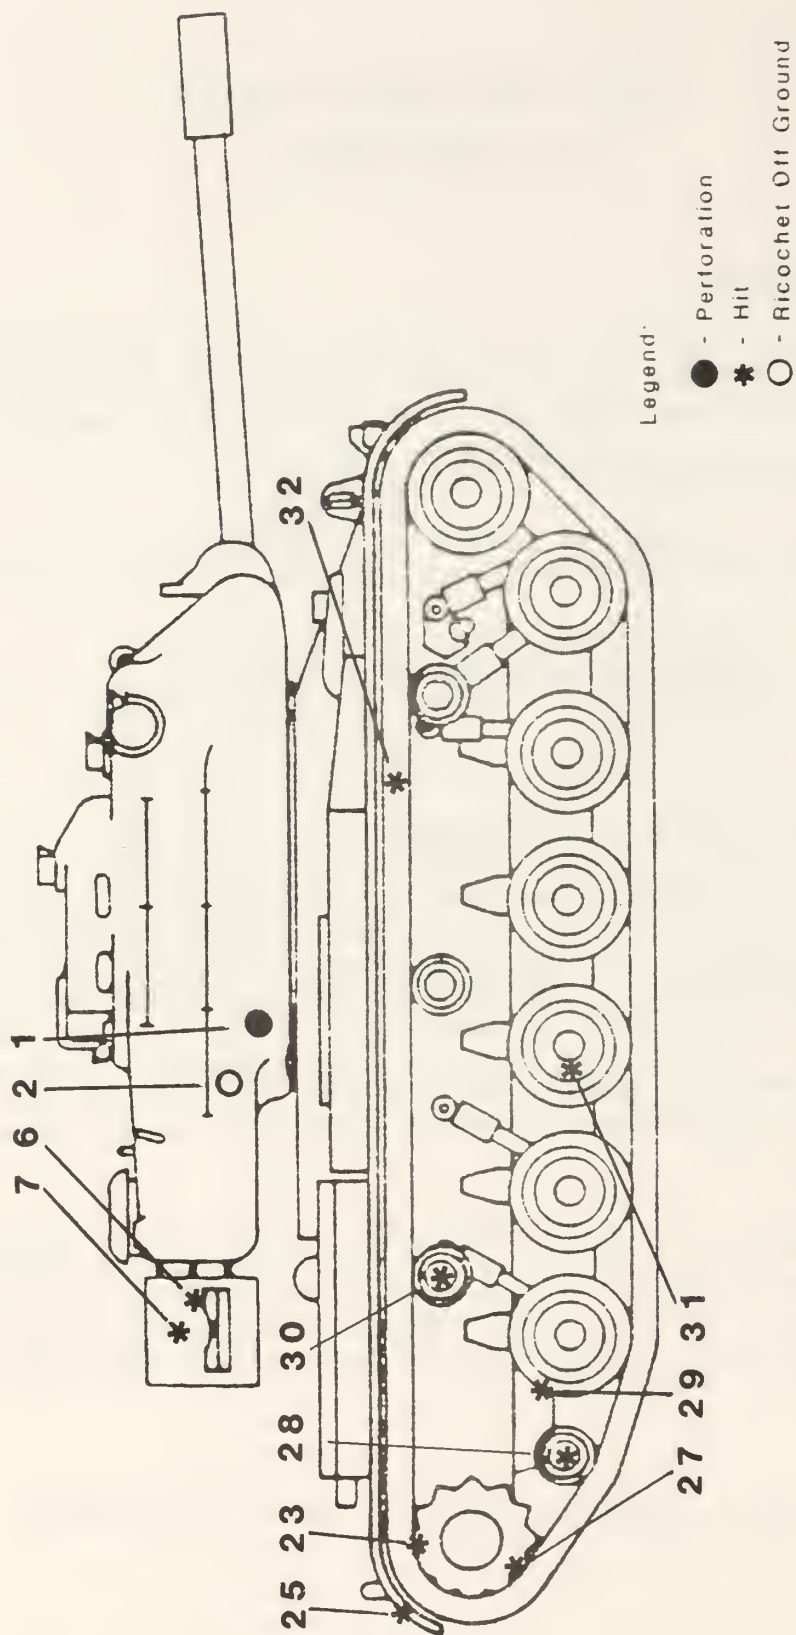
FIGURE 18. Tank 4, Impact Diagram.

100% M-Kill and 100% F-Kill resulting from the following observed effects (Figures 18, 19, and 20):

- a. M-Kill: The assessment of a 100% M-Kill is based on impacts 15 and 16 (Figure 21) which perforated the rear hull armor and penetrated into the engine compartment, severing two oil cooler lines and penetrating the transmission case; and on cumulative damage to the track and suspension system caused by impacts 19, 25, 28, 30, 31, and 32. Crew casualties caused by impact 1 contributed to the kill.
- b. F-Kill: The assessment of a 100% F-Kill is based on impact 3 which hit in the turret ring and jammed the turret so that it would not traverse, and on impact 1 (Figure 22) which perforated the turret and caused casualties to the commander, gunner, and loader.

NOTE: Hits 19 and 20 impacted on the inside of the left compensating idler wheel and the left track respectively.

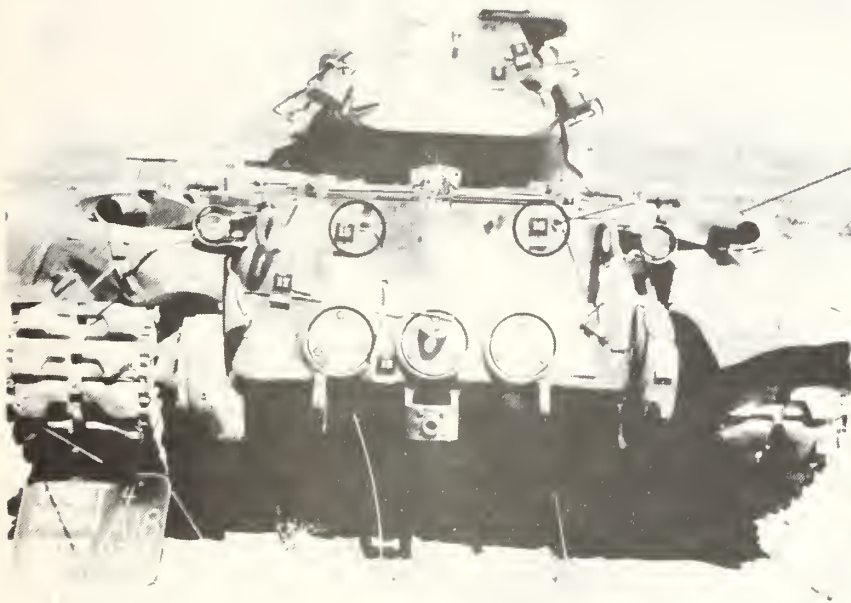
FIGURE 21. Tank 4, Photo, Rear.

Note impacts 15  
and 16 which per-  
forated rear hull  
and penetrated  
into transmission  
case and oil cooler  
lines.

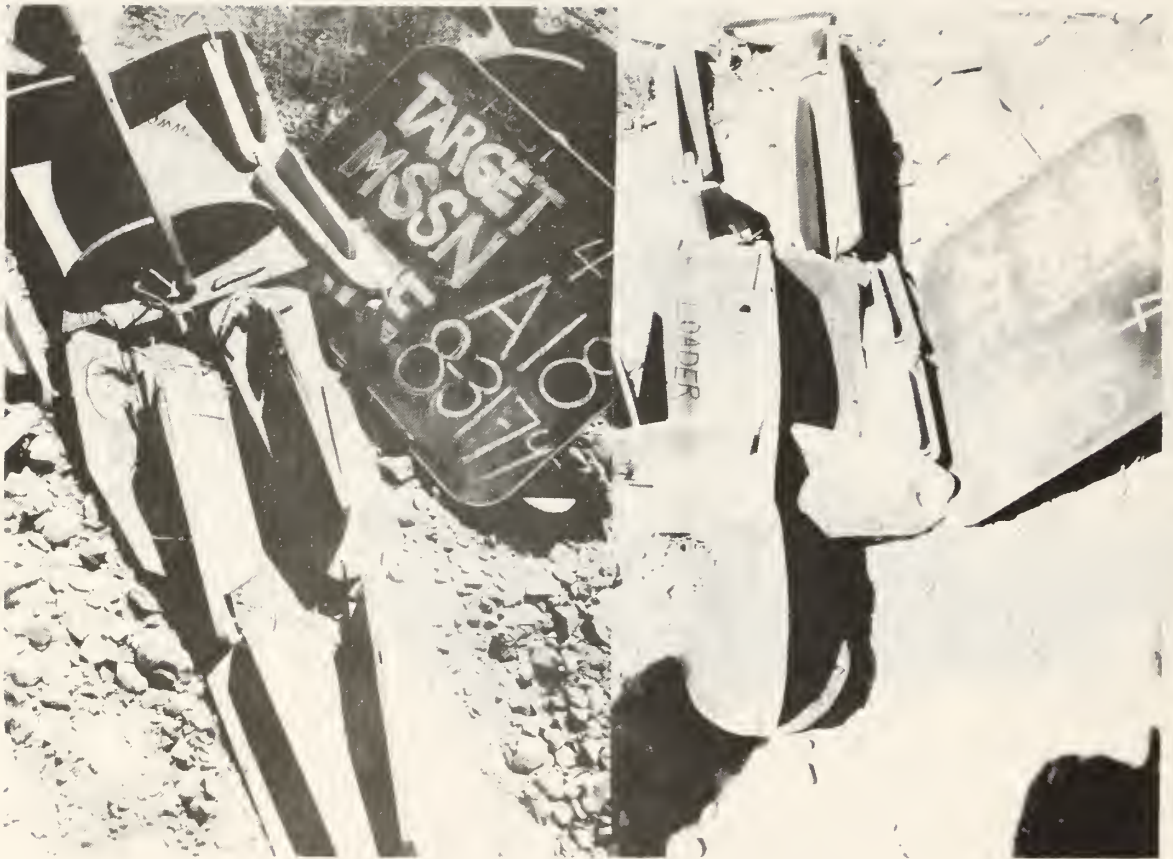
FIGURE 22. Tank 4, Photo, Commander and Loader.

Note fragmentation effects on commander and loader manikins from impact 1.

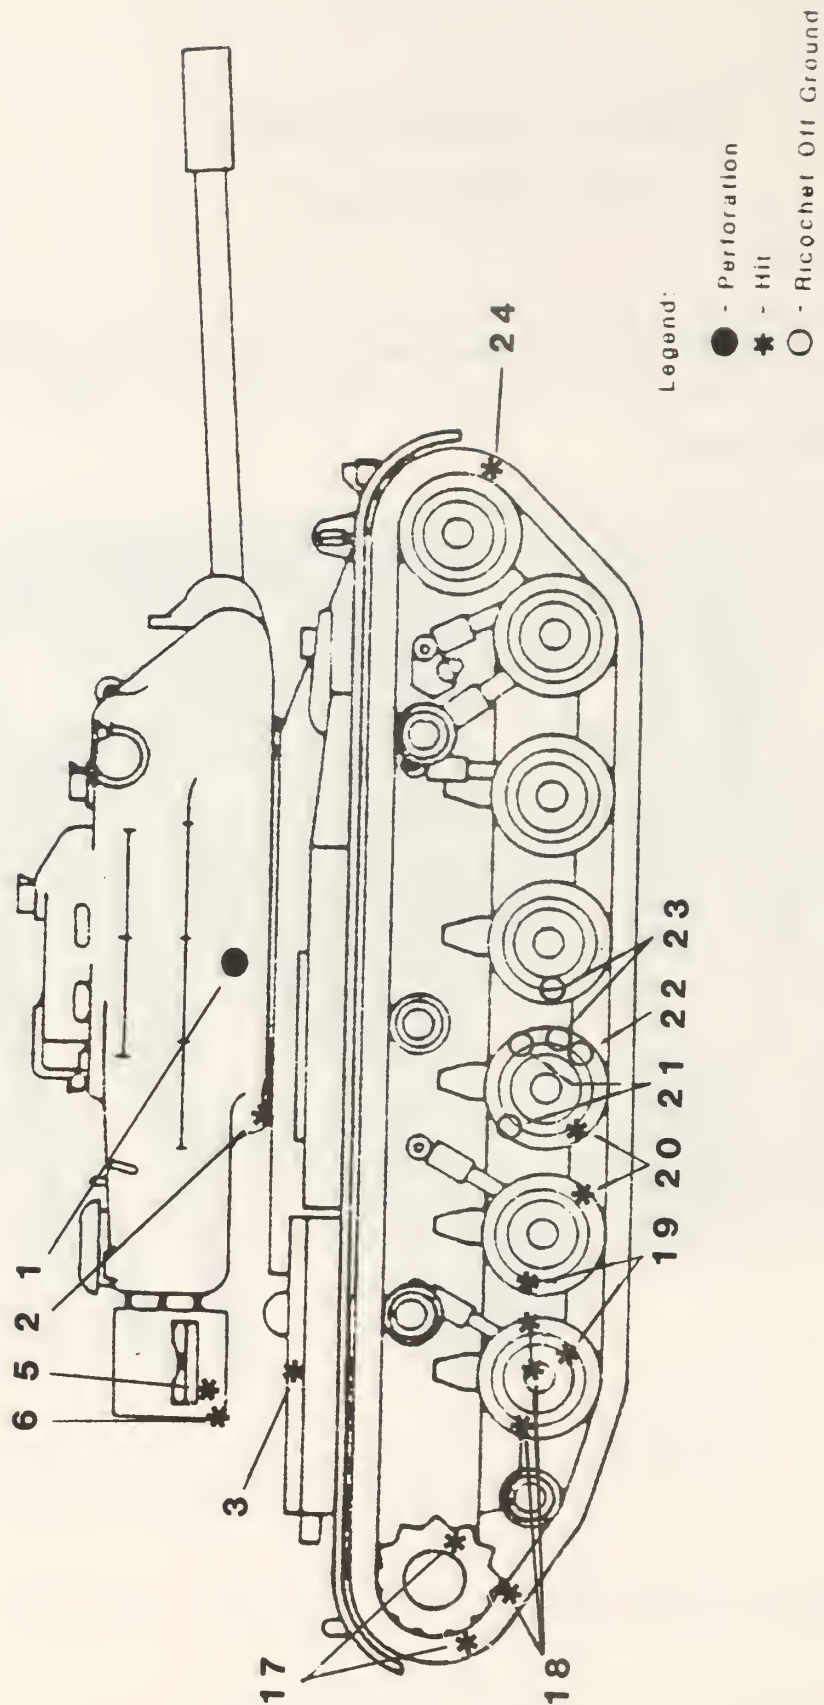
FIGURE 23. Tank 7, Impact Diagram, Right Side.

100% M-Kill and 100% F-Kill resulting from the following observed effects (Figures 23 and 24):

- a. M-Kill: The assessment of a 100% M-Kill is based on impacts 12 and 13 which perforated the rear of the hull penetrating into the transmission case, and on cumulative damage to the track and suspension system caused by impacts 14, 17, 18, 19, and 24.
- b. F-Kill: The assessment of a 100% F-Kill is based on impact 1, which perforated the right side of the turret killing the gunner and damaging the commander's main armament controls, and impact 2 which jammed the turret so that it could not be traversed (Figure 25).

NOTE: Impacts 4,7,8,9, and 10 are not shown. These impacts struck the top surface of the tank and resulted in minor external damage.

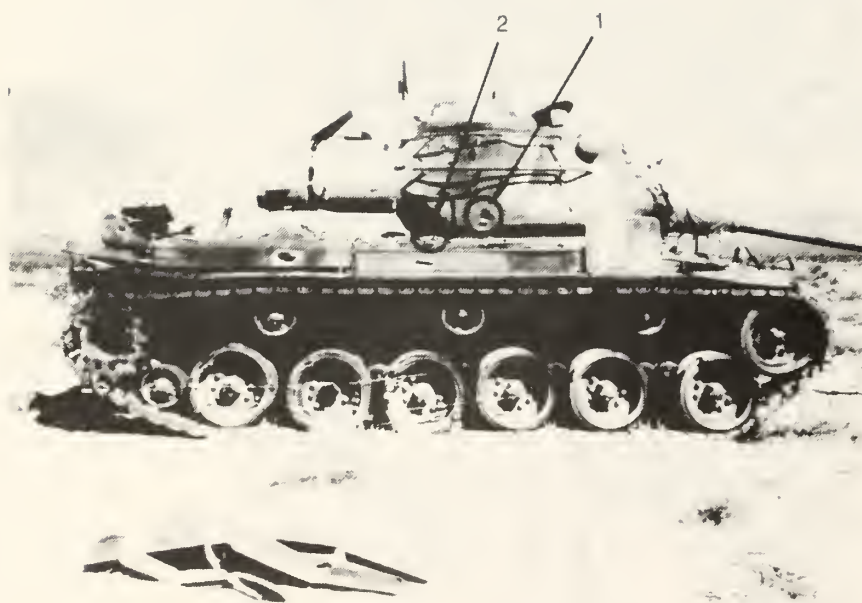
FIGURE 25. Tank 7, Photo, Right Side.

Note impacts 1  
(perforation) and  
2 (hit, which  
jammed turret).

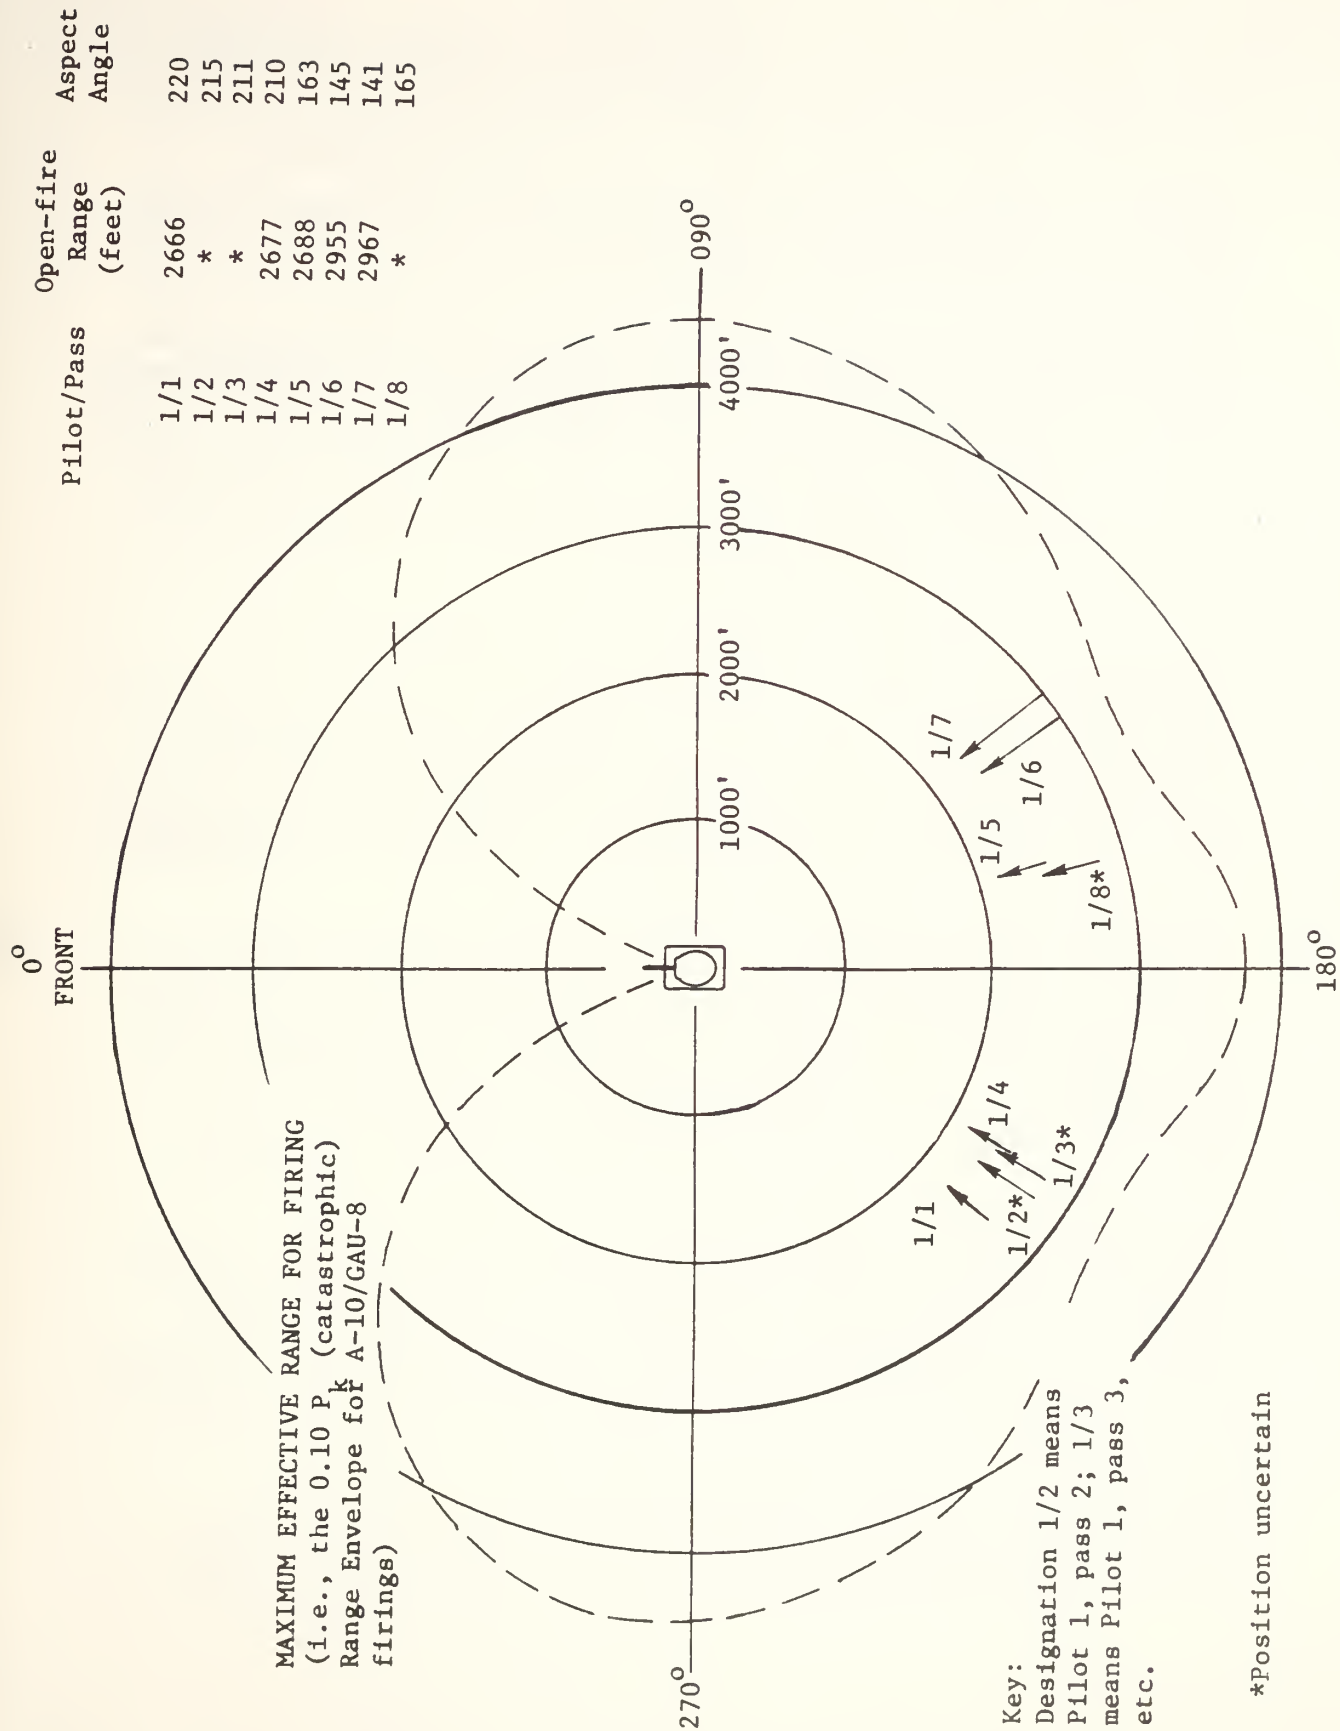
FIGURE A-1. Array 18 Attack Aspect Summary.

Table A-I contains a summary of the results of Mission 18 of 30 August, 1979. Table A-II contains a summary of damage assessment based on perforation locations. Table A-III contains a summary of aircraft attack parameters. Figure A-1 depicts aircraft attack aspect by tank number as a function of open-fire range.
